MARYLAND HISTORICAL TRUST  
DETERMINATION OF ELIGIBILITY FORM

Property Name: Clifton-on-the Monocacy Inventory Number: F-1-189  
Address: 4007 and 3995 Buckeystown Pike City: Buckeystown Vicinity Zip Code: 21704  
County: Frederick USGS Topographic Map: Buckeystown  
Owner: Howard R. and Virginia T. Crum Is the property being evaluated a district? \_\_\_yes  
3 and  
Tax Parcel Number: 218 Tax Map Number: 95 Tax Account ID Number: 013904  
Project: St. John's Catholic Prep New Campus Development Agency: USDA Rural Development Program Funding  
Site visit by MHT Staff: X no \_\_\_yes Name: \_\_\_\_\_ Date: \_\_\_\_\_  
Is the property located within a historic district? \_\_\_yes X no

**MARYLAND HISTORICAL TRUST  
NR-ELIBILITY REVIEW FORM**

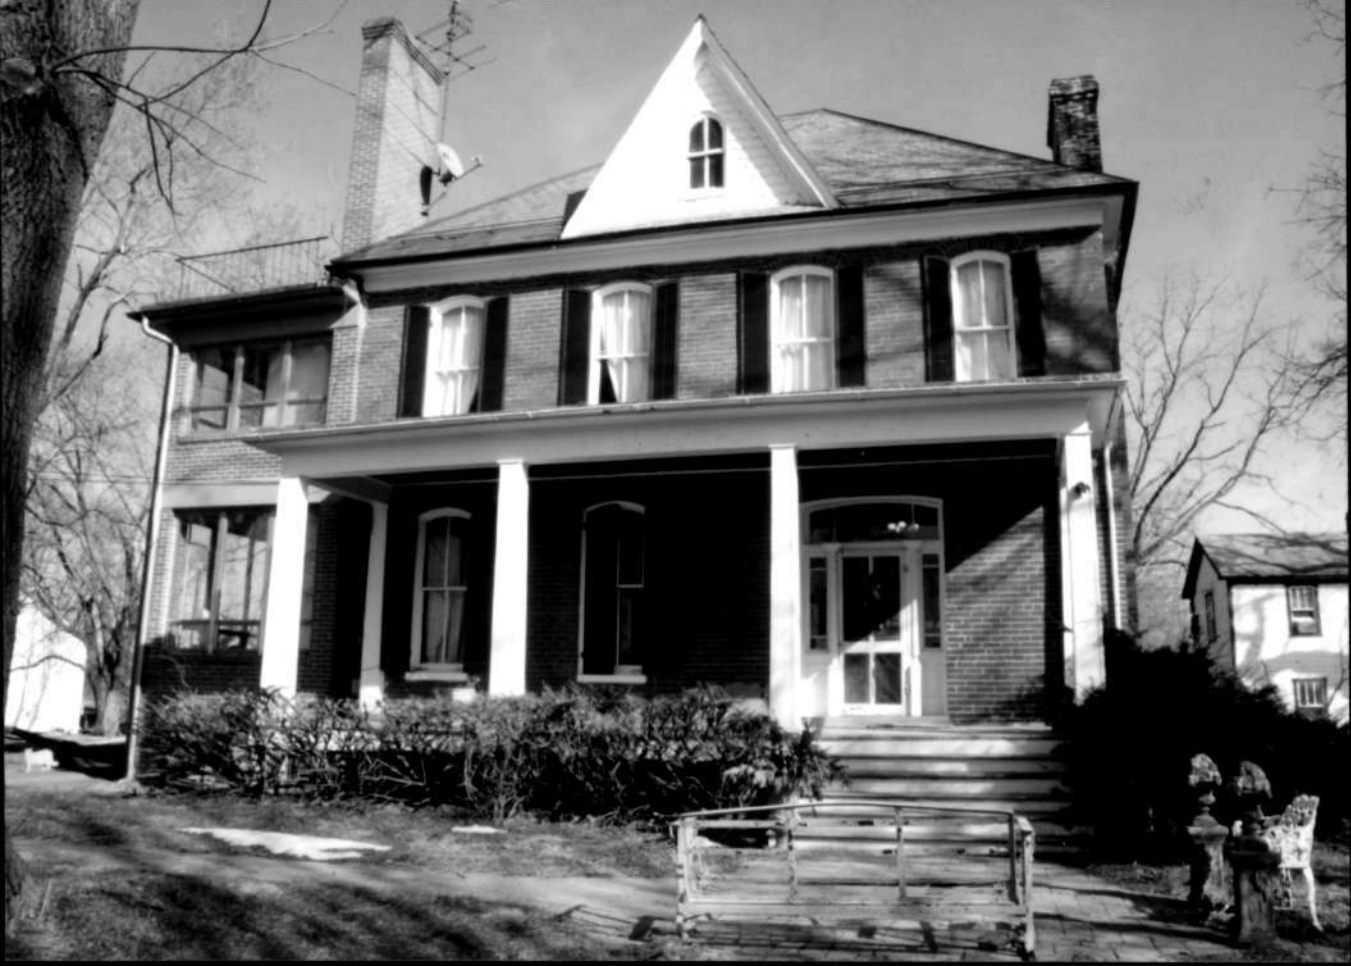
MIHP # F-1-189  
CLIFTON - ON - THE - MONOCACY  
FREDERICK COUNTY, MD  
GODWIN & ASSOC. INC, MARCH 2010  
MAIN DWELLING - WEST ELEVATION  
4 OF 20

The dwelling faces west. The house rests on a rubble-stone foundation and terminates in a hipped roof that features lower cross gables. The roof is sheathed in slate and features patterns of half-round and half-cut shingles. A metal snow-bird system and half-round, terne metal gutters have been installed. The front (west), south, and rear (east) gables are clad with half-round and half-cut wood shingles. The front and south gables contain a two-over-two-light, wood-frame, round-arched window. The rear gable contains two two-over-two-light, wood-frame, square windows and has cornice returns. The north gable is clad with weatherboard and contains a door rather than a window.

Exterior walls are laid in 7:1 common bond and are crowned with a plain wood cornice. Window and door openings are defined by segmental arches. Windows are two-over-two-light, double-hung, wood-frame units with wood blinds. The front elevation has three bays on the first story and four on the second. The off-center, four-panel, wood door features a three-light transom and three-light sidelights; the door is flanked by fluted, engaged wood columns. A one-story, flat-roofed porch extends along the full width of the front elevation. Porch materials include brick piers, wood lattice, wood stairs, square wood columns, and a tongue-and-groove wood floor and ceiling. The porch is accessed by a walkway and patio laid with stone pavers.

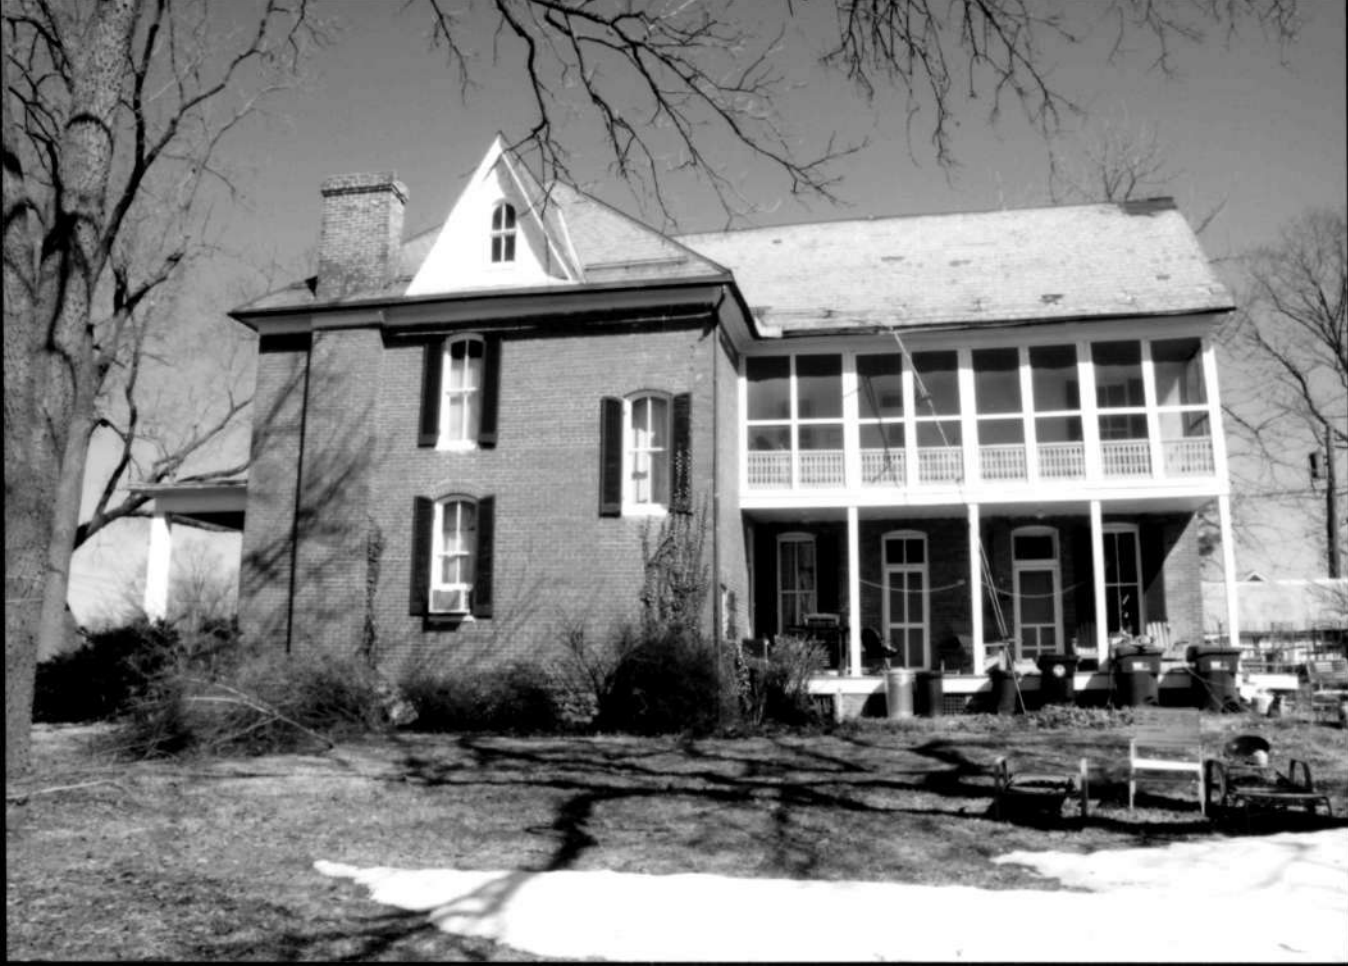
5 OF 26

The window fenestration of the south side of the dwelling is staggered due to the location of the interior stairway; an exterior brick chimney rises along the west end of this elevation. A two-story integral porch is located within the ell; materials are the same as those of the front porch. Two windows and three four-panel, wood doors with transoms open onto the porch's first story; wood-frame screen doors also are present. The second story of the porch is enclosed by wood-frame screens; a scroll-sawn balustrade is visible behind the screens. Two wood doors and two windows open onto the porch's second story.

MAIN DWELLING - SOUTH ELEVATION

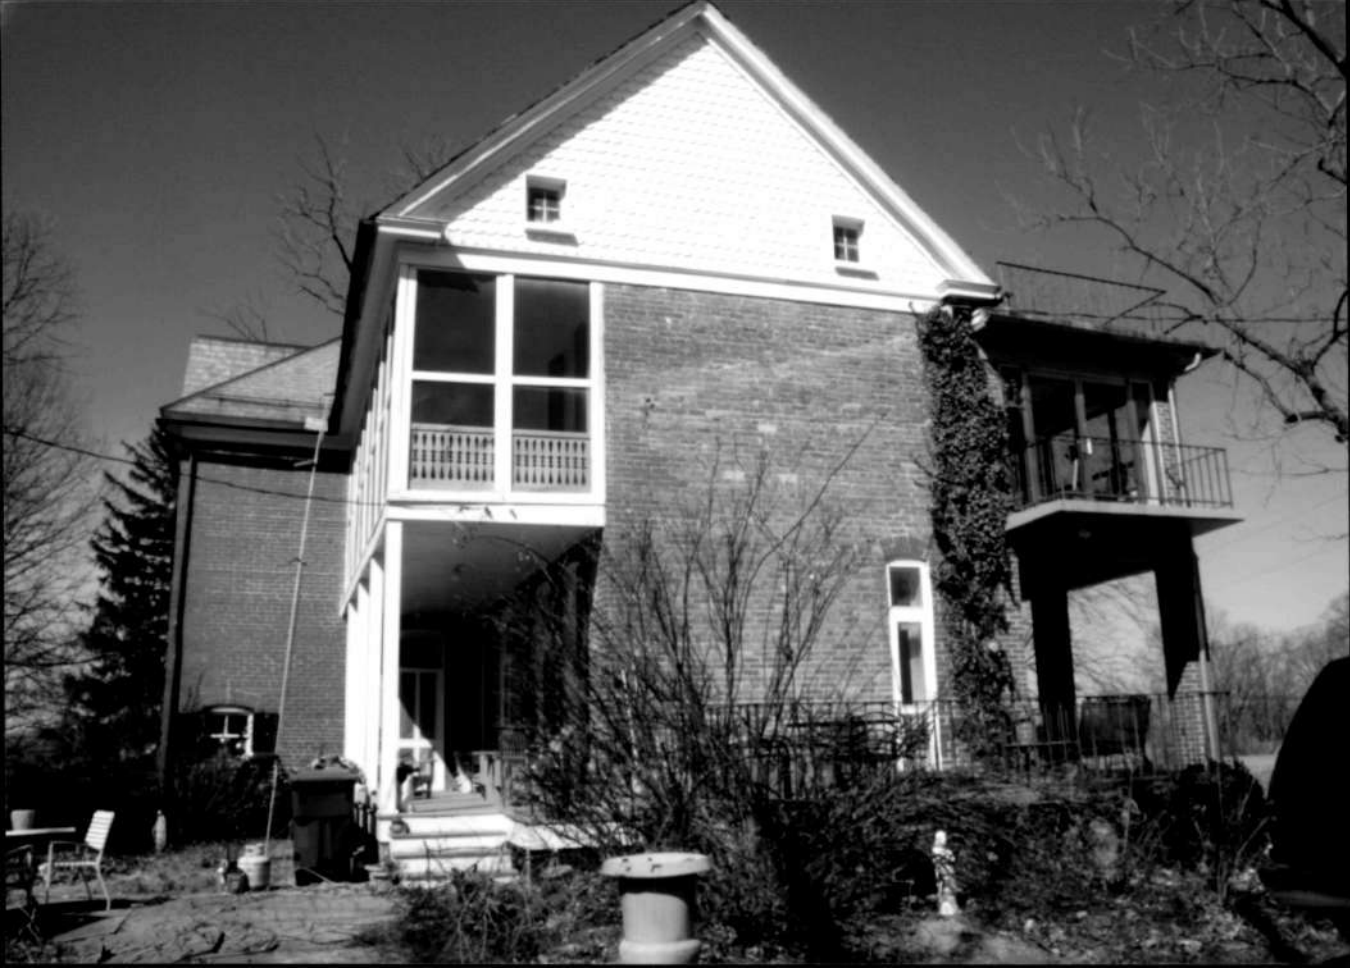
6 OF 26

The rear elevation of the dwelling contains a narrow wood door crowned by a transom. The door opens onto a raised patio constructed of brick pavers. The raised patio, which was built in 1968, is surrounded by a metal railing (Howard and Virginia Thomas personal communication 17 March 2010). Ivy grows along the base of the raised patio and continues up the rear elevation of the dwelling. A brick patio laid in running bond connects the main dwelling to the domestic service building located southeast of the dwelling. A concrete patio is located off the southwest corner of this brick patio.

MAIN DWELLING - EAST ELEVATION

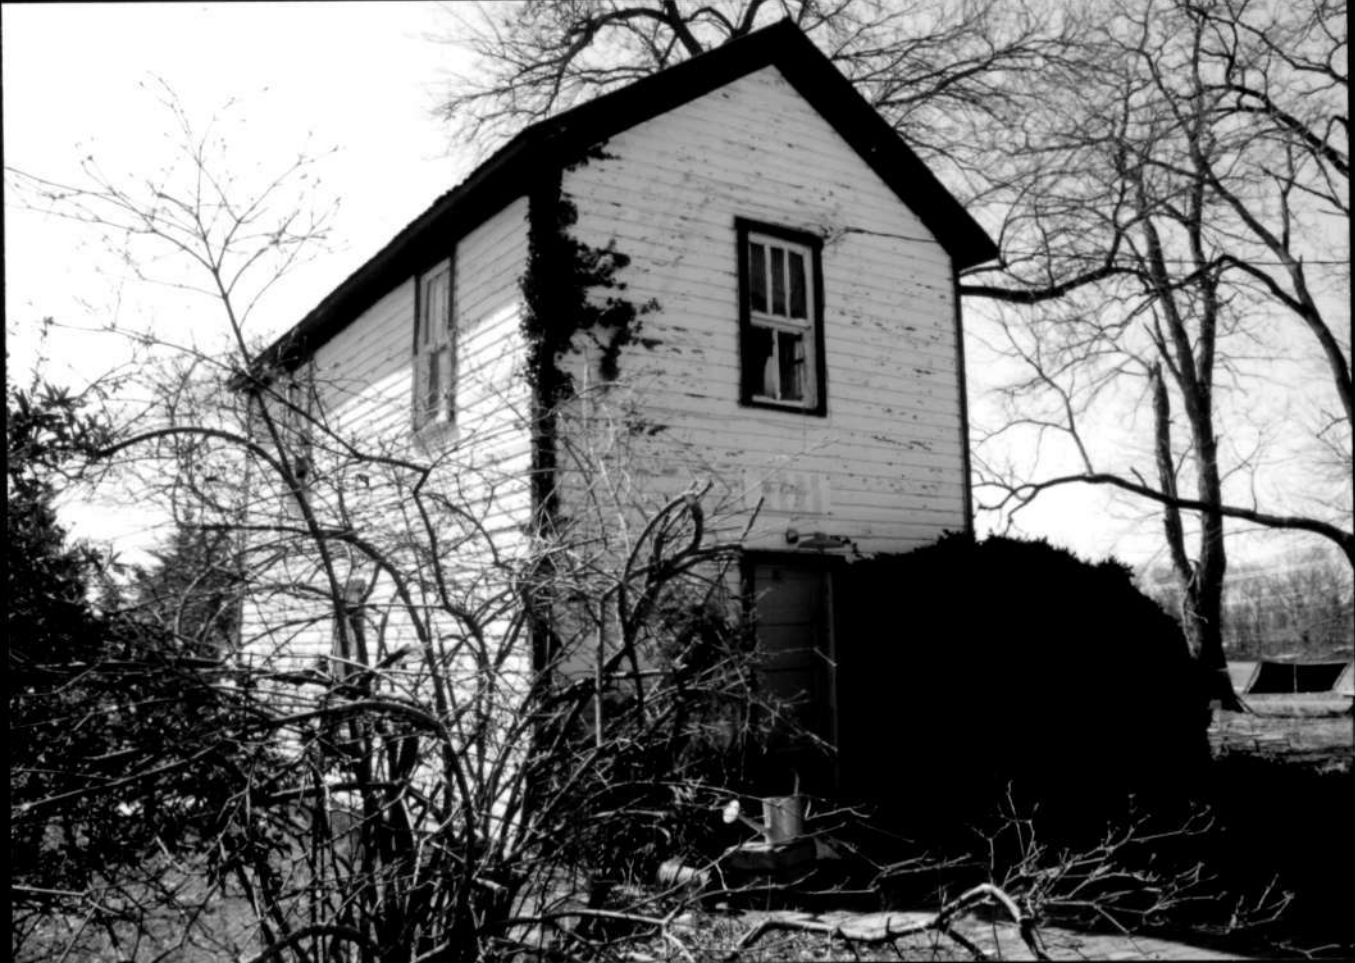
12 OF 26

The two-story, wood-frame, domestic service building constructed ca. 1895 is located at the southeast corner of the main dwelling. The building's original use is not clear; it may have been constructed as a summer kitchen, as a wash house, or for dairy-related tasks. The rectangular-shaped building faces north, rests on a hollow, interlocking, structural terra cotta-block foundation, and terminates in a front-gable roof sheathed in corrugated metal. A brick chimney rises at the center of the roof ridge. Exterior walls are clad with drop wood siding. The front (north) elevation contains a five-panel wood door and a three-over-two-light, double-hung, wood-frame window. The side elevations contain three-over-one-light, double-hung, wood-frame windows.

A one-story, shed-roof addition was constructed along the south elevation by 1945 (Pahlow 1945). Exterior walls are clad with tongue-and-groove, horizontal wood siding, and the roof is sheathed in V-groove metal. The addition features two six-light, fixed, wood-frame windows and a tongue-and-groove wood door.

DOMESTIC SERVICE BUILDING - NORTHEAST CORNER

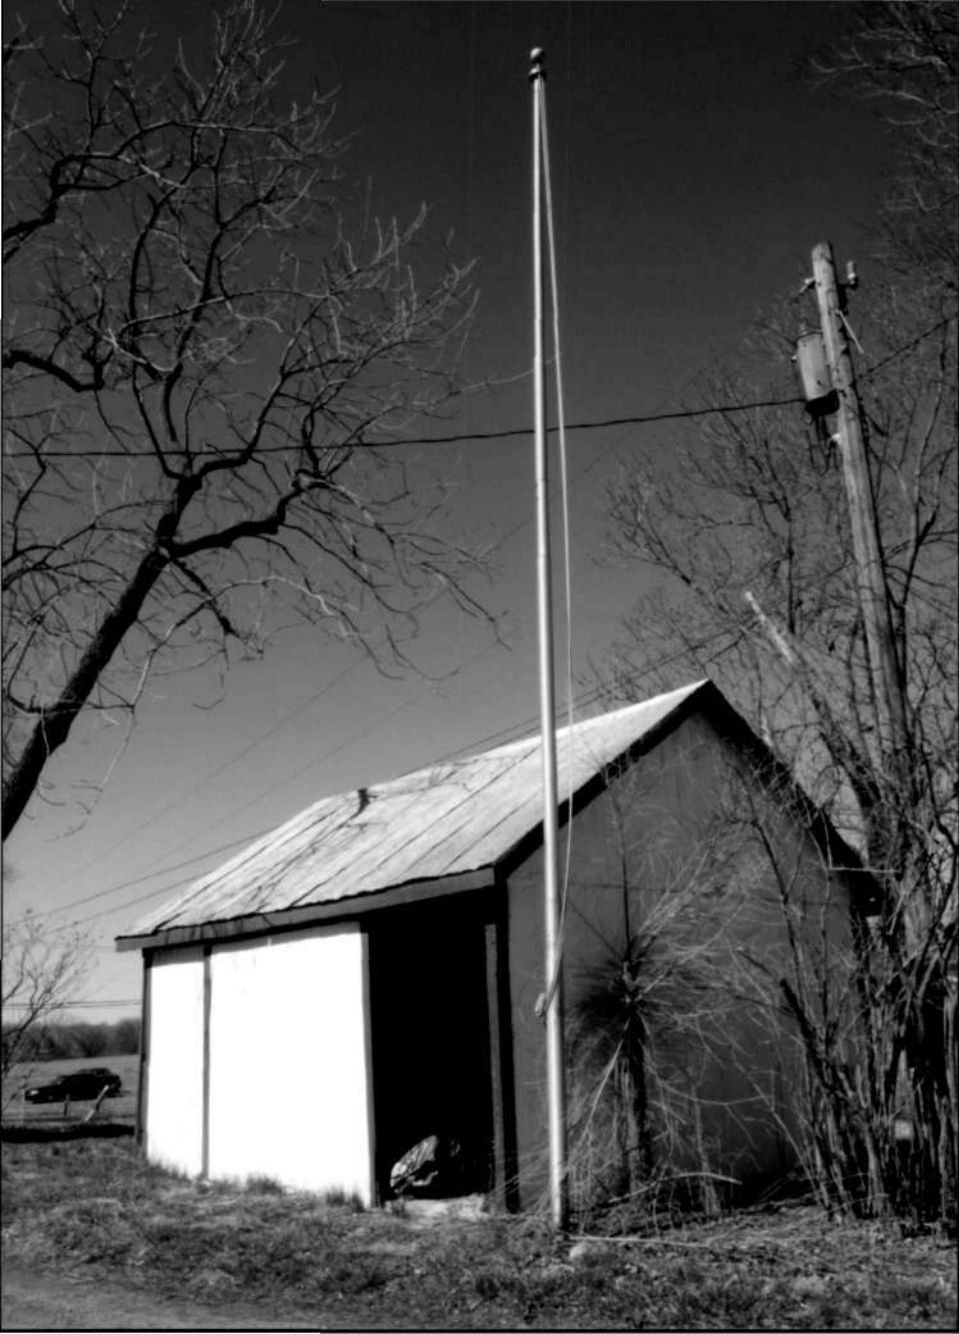
13 OF 26

The one-story, wood-frame garage constructed ca. 1950 is located at the northeast corner of the main dwelling (Pahlow 1945). The rectangular-shaped garage faces south and rests on a poured-concrete foundation. The gable roof is sheathed in corrugated metal. Exterior walls are clad primarily with tongue-and-groove, vertical wood siding. A sliding, tongue-and-groove wood door is located on the front (south) elevation. The rear (north) elevation contains two nine-light, fixed, wood-frame windows.

GARAGE - SOUTHEAST ELEVATION

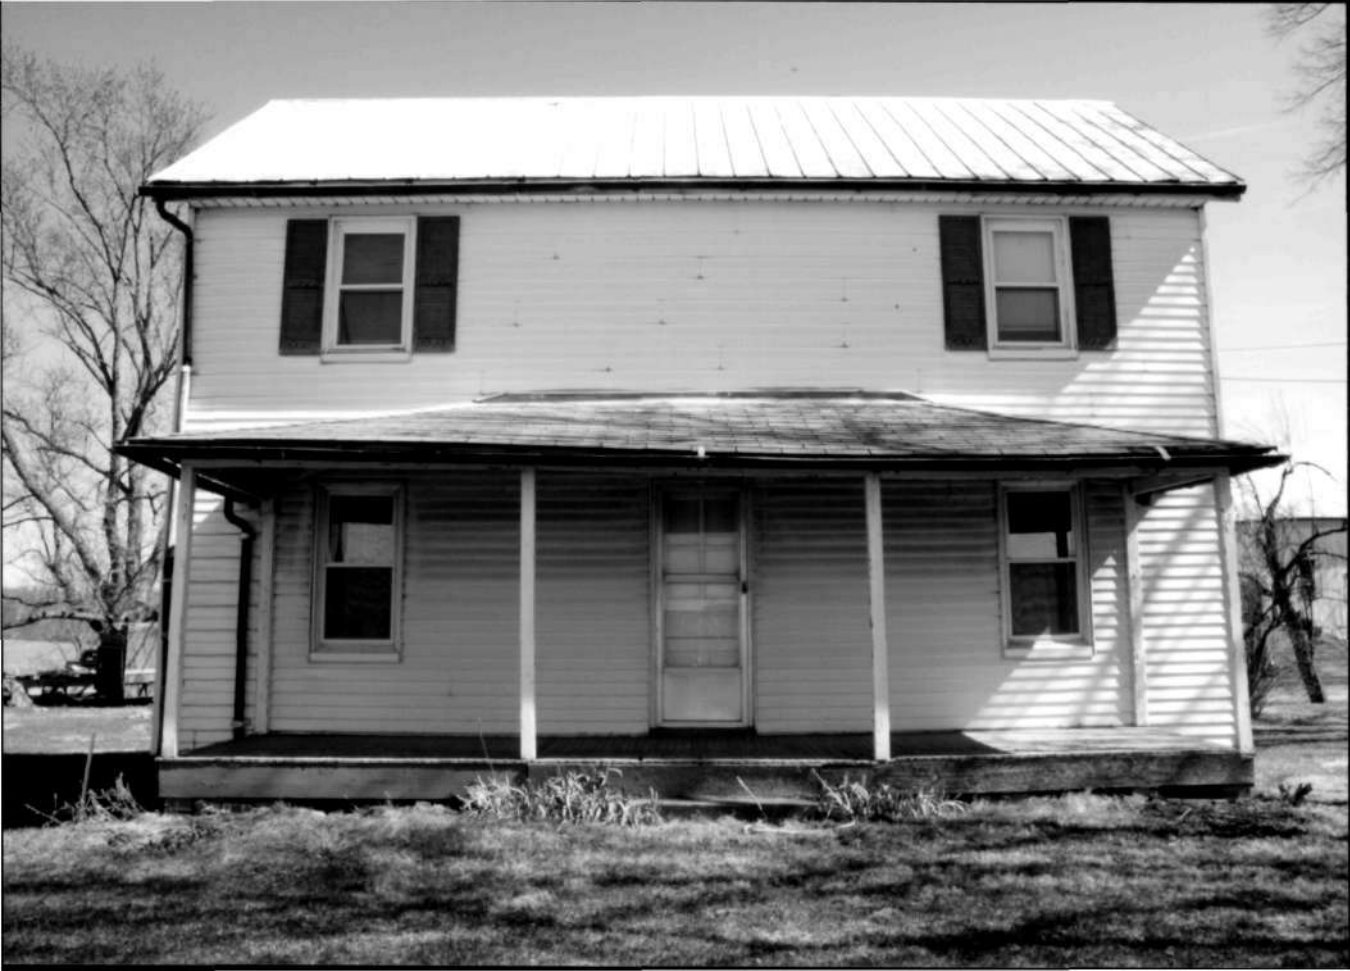
14 OF 26

The two-story, T-shaped, wood-frame tenant house is located northeast of the main dwelling and faces west. The house, which was constructed ca. 1925, was moved to its present location in 1952 from a site northeast of the agricultural complex (Howard and Virginia Thomas personal communication 9 March 2010; Pahlow 1945). The tenant house comprises a gable-roof main block and a shed-roof rear wing. The house has a concrete-block foundation, exterior walls are clad with vinyl siding, and the roof is sheathed in V-groove metal. All windows but one are one-over-one-light, double-hung, prefabricated replacement units; the exception is a two-over-two-light, double-hung, wood-frame window on the second story of the wing's north elevation. Each gable contains a four-light, fixed, wood-frame window.

The three-bay front (west) elevation has three bays on the first story and two on the second. The centrally-located, four-light, wood-panel door is protected by a metal storm door. A one-story, hipped-roof porch extends across most of the front elevation. The porch rests on brick piers and features square wood posts, tongue-and-groove wood floor and ceiling, and asphalt roof shingles.

TENANT HOUSE - WEST ELEVATION

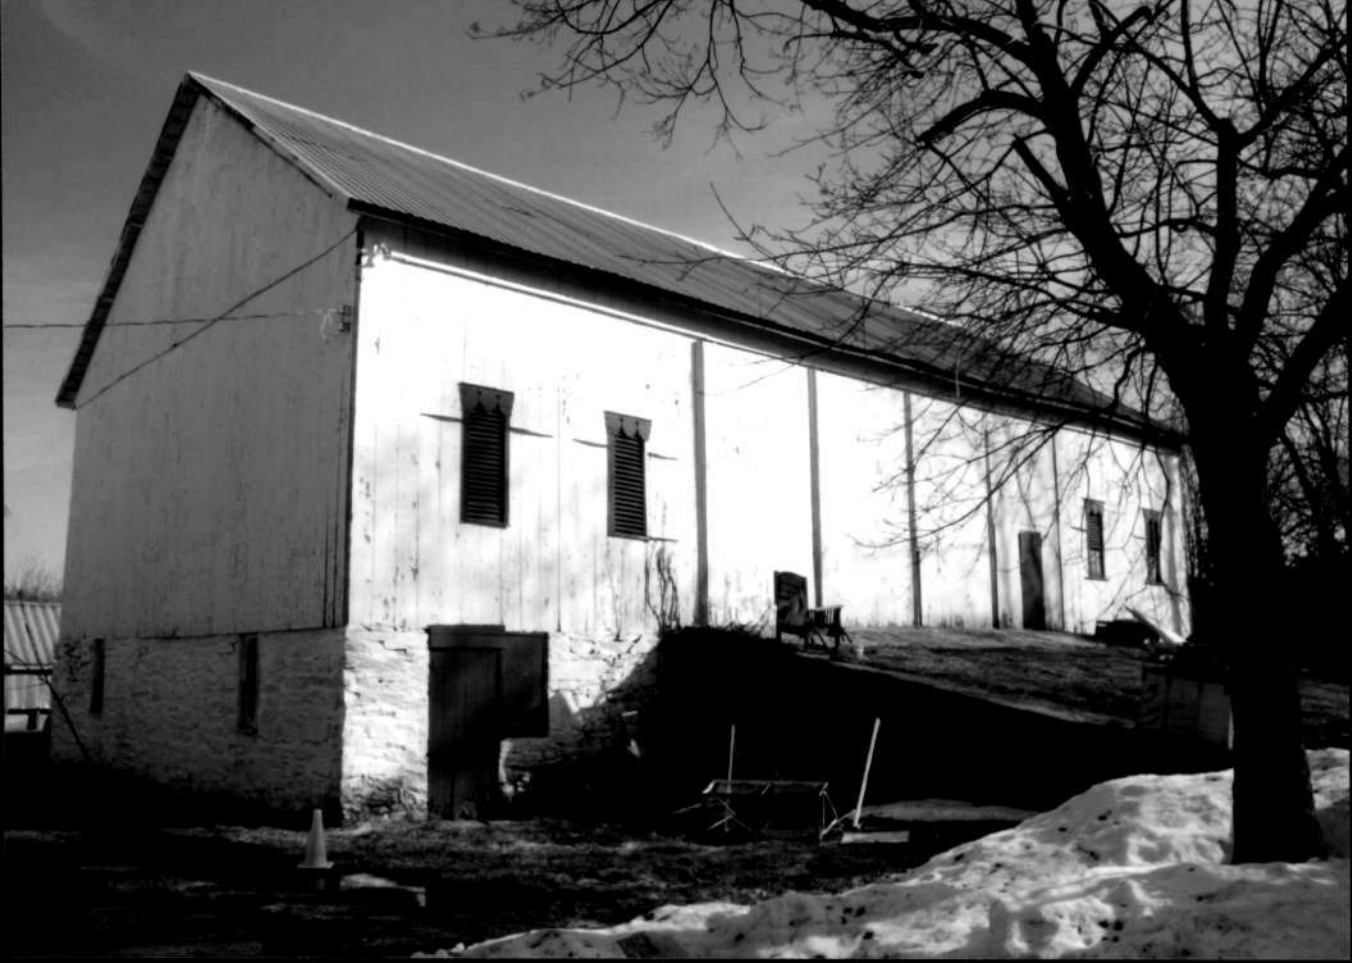
17 OF 26

The wood-frame, gable-roof bank barn was constructed ca. 1895 northeast of the main dwelling (Williams and McKinsey 1910:1412). The barn occupies a rectangular footprint and rests on a rubble-stone foundation. The roof is sheathed in V-groove metal. Exterior walls are clad with vertical-board siding that is painted white. The bank ramp, which is located along the west elevation, provides access to sliding tongue-and-groove wood doors. Wood pedestrian doors are located on the west and east elevations. A roughly cut door opening is located in the foundation of the south elevation. Wood louvers with scroll-sawn ornamentation pierce all elevations except the north side. The foundation of each short (east and west) elevation contains two six-over-six-light, wood-frame windows.

BANK BARN - NORTHWEST CORNER

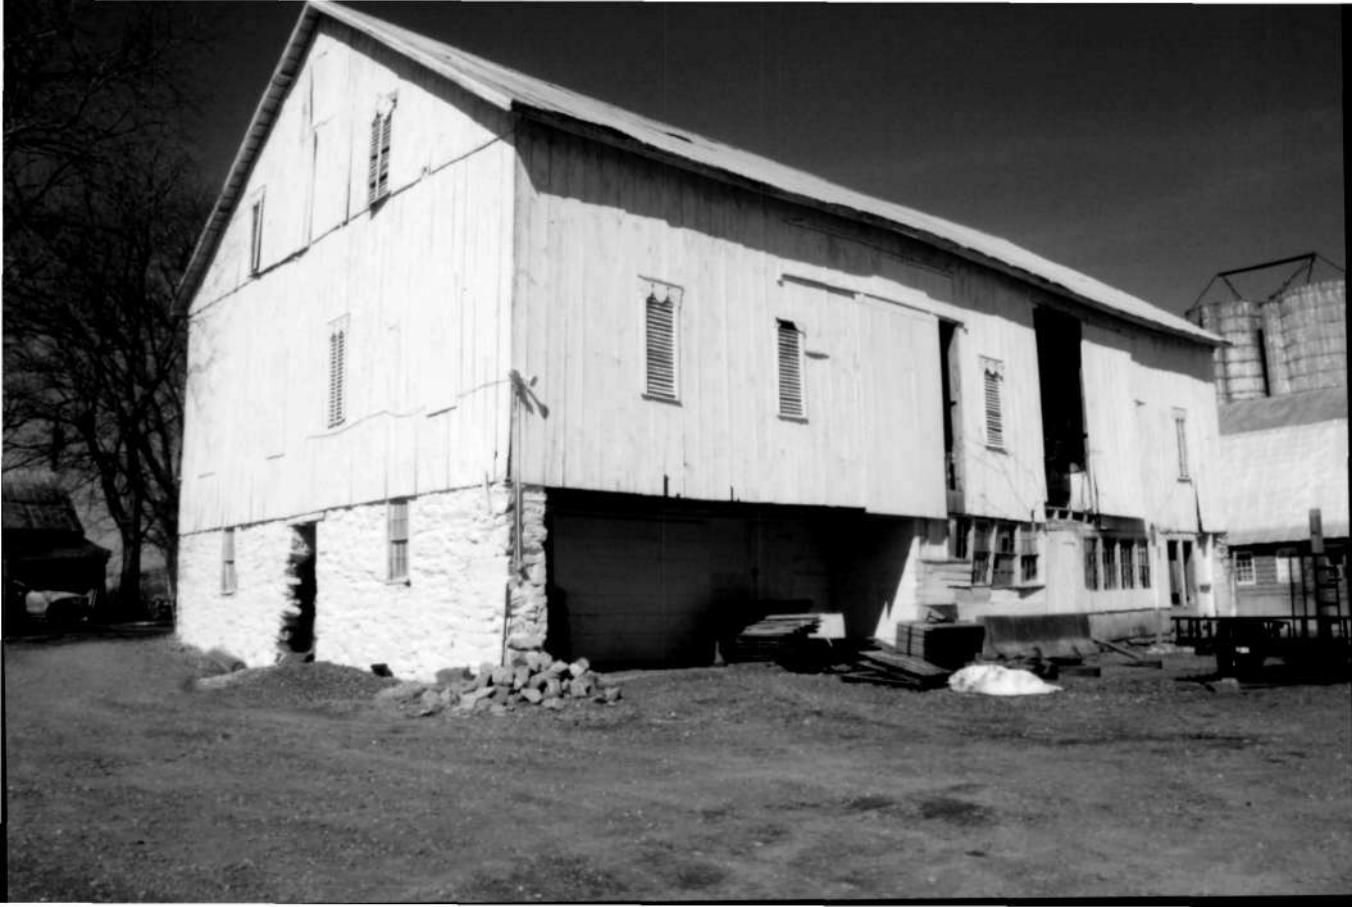
18 OF 26

The east elevation of the bank barn includes two sliding wood doors on the upper level. On the lower level, the southern half of the east elevation contains a closed forebay. The northern half has a poured-concrete foundation and contains two groups of four six-over-six-light, wood-frame windows. This section encloses animal stalls and ca. 1920 milking stanchions on the lower level.

BANK BARN - SOUTHEAST CORNER

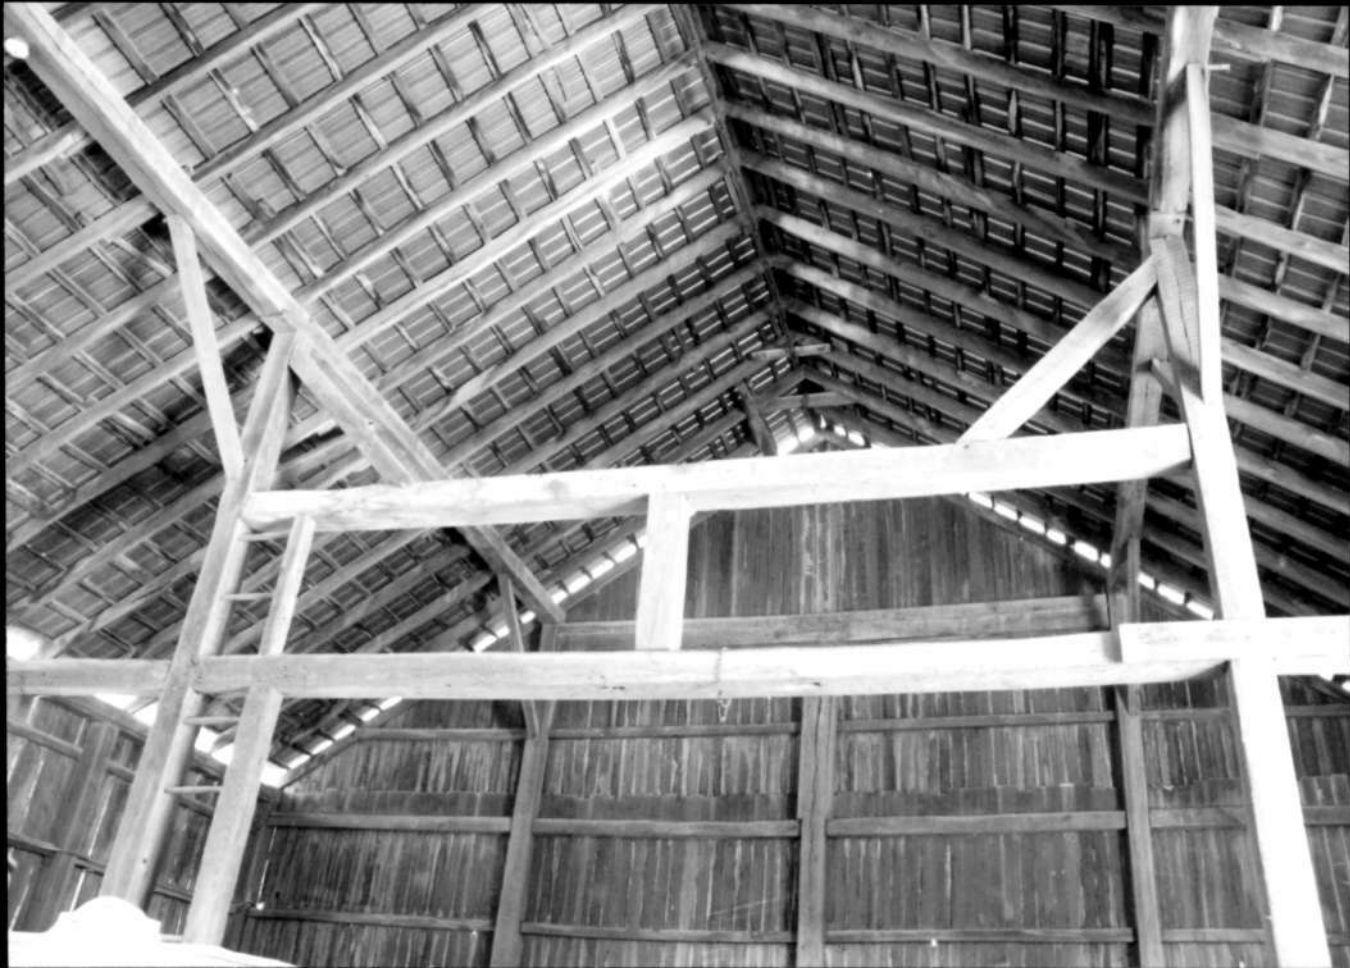
19 OF 26

The barn is constructed with circular-sawn framing members, pegged mortise-and-tenon joints, and wire nails. The interior features a threshing floor flanked by hay mows, a common-rafter roof, and wide-board floors. The lower level has a tongue-and-groove wood ceiling in the milking area.

BANK BARN - INTERIOR - VIEW NORTH

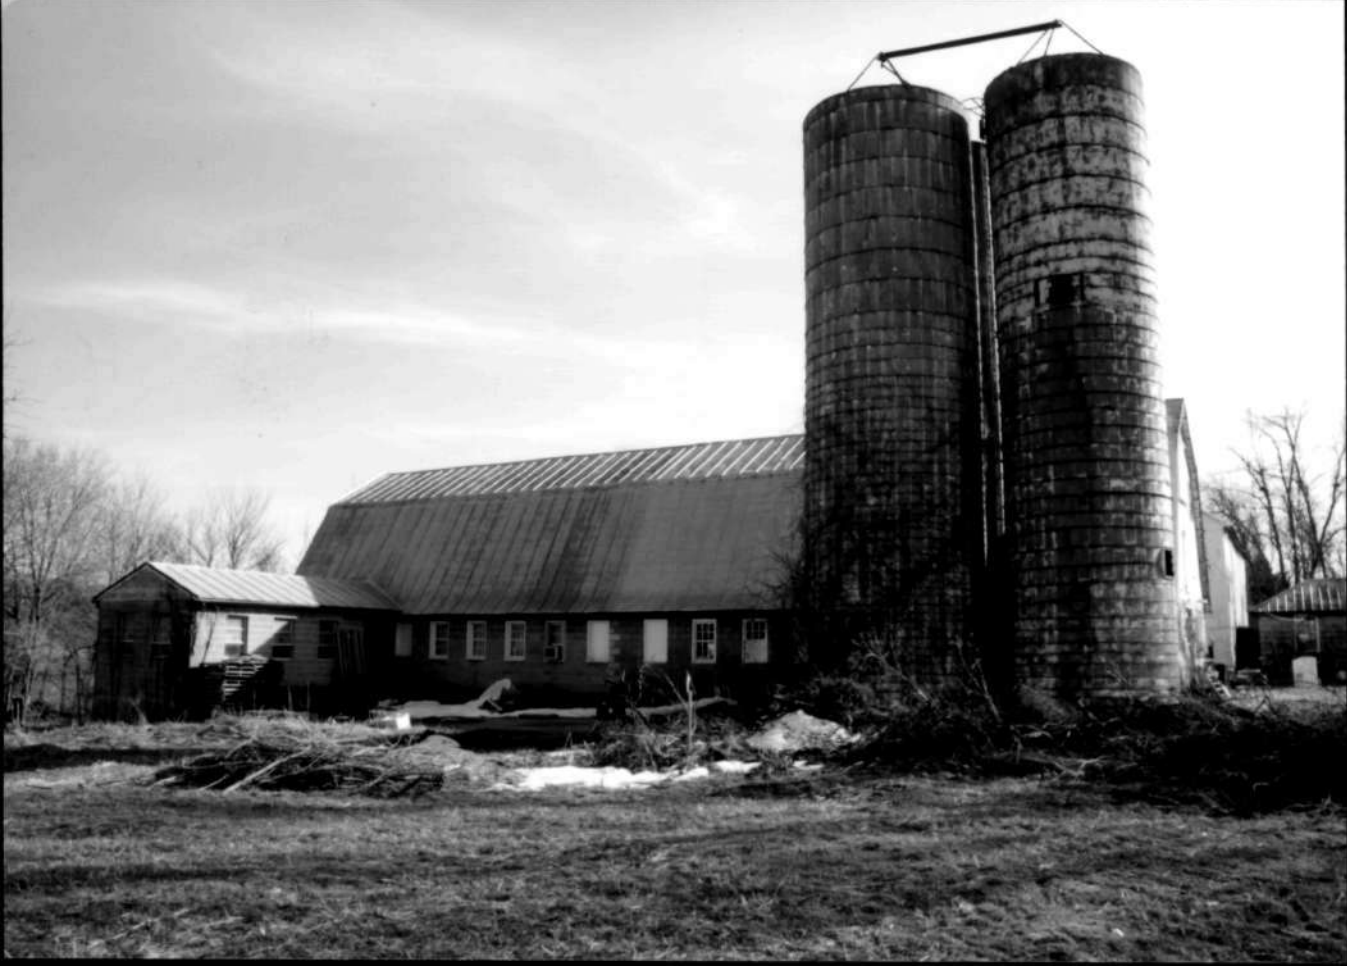
21 of 26

The ca. 1942 rear extension of the barn includes a one-story, concrete-block dairy attached to the east end of the north elevation. The dairy rests on a poured-concrete foundation and terminates in a gable roof. The gable is clad with drop wood siding. The dairy features three-light, metal-frame, awning windows. Paired metal doors are located on the rear elevation. The two silos are located on the west end of the north elevation. These cylindrical, interlocking concrete stave silos are encircled with adjustable steel cables.

DAIRY BARN, ATTACHED DAIRY & SILOS -  
NORTH ELEVATION

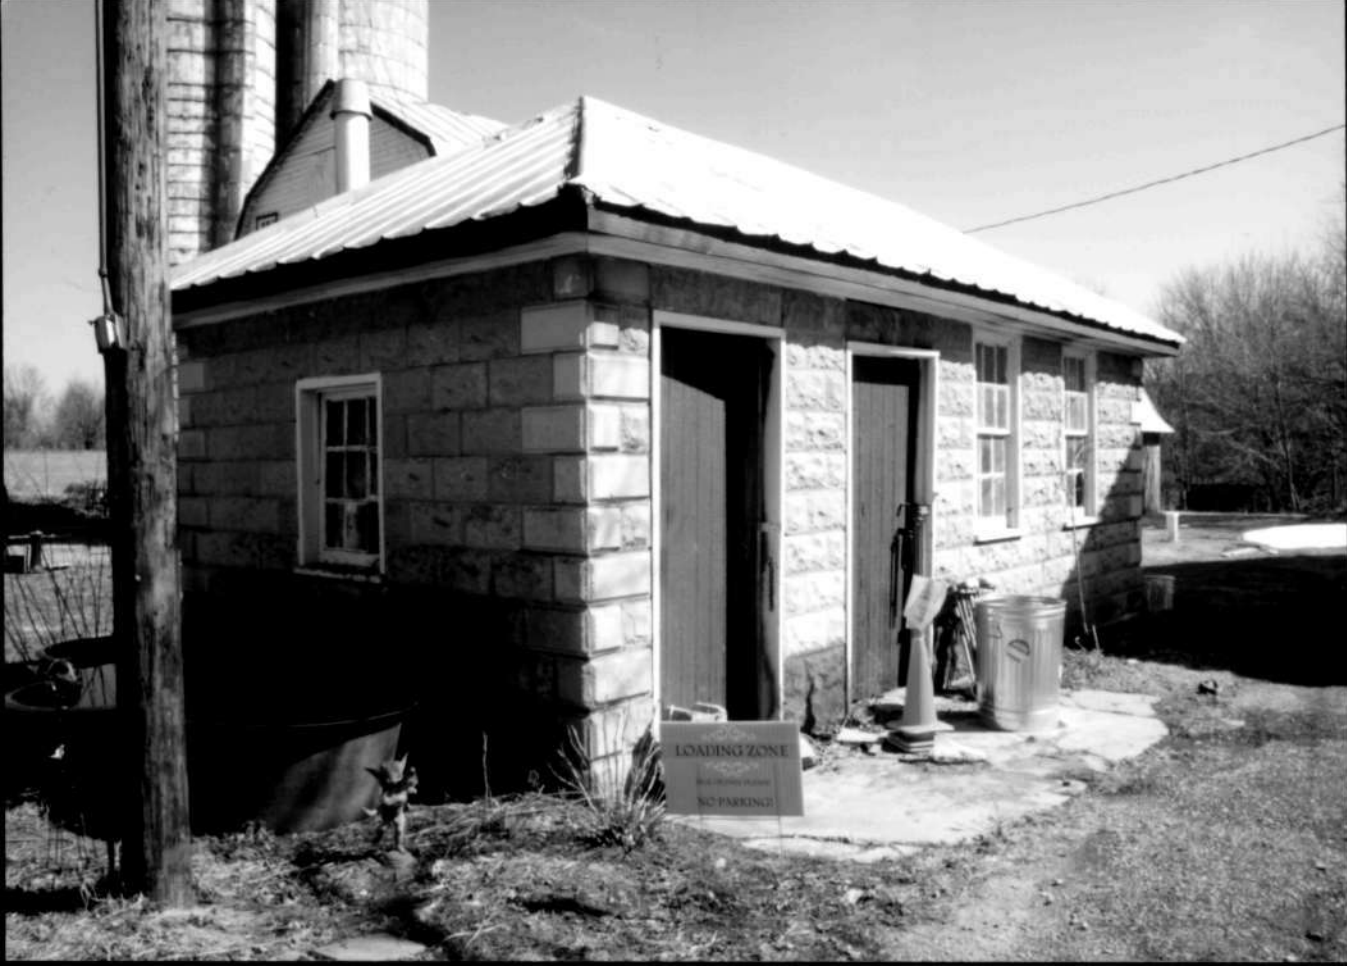
22 OF 26

The milk house was constructed ca. 1930 concurrently with the dairy barn. The milk house is located southwest of the dairy barn and faces south. The building occupies a rectangular footprint and rests on a poured-concrete foundation. The hipped roof is sheathed in V-groove metal. A stove pipe rises from the north roof ridge. Exterior walls are rough-textured, rusticated concrete block. Smooth-textured, rusticated concrete-block quoins similar to those on the dairy barn define the corners of the milk house. The milk house features three tongue-and-groove wood doors: two on the front (south) elevation and one on the east elevation. The front and rear (north) elevations each contain two six-over-six-light, wood-frame windows. A nine-light, wood-frame window is present on the west elevation. The interior of the milk house includes a poured-concrete floor and a tongue-and-groove wood

MILKHOUSE - SOUTH WEST CORNER

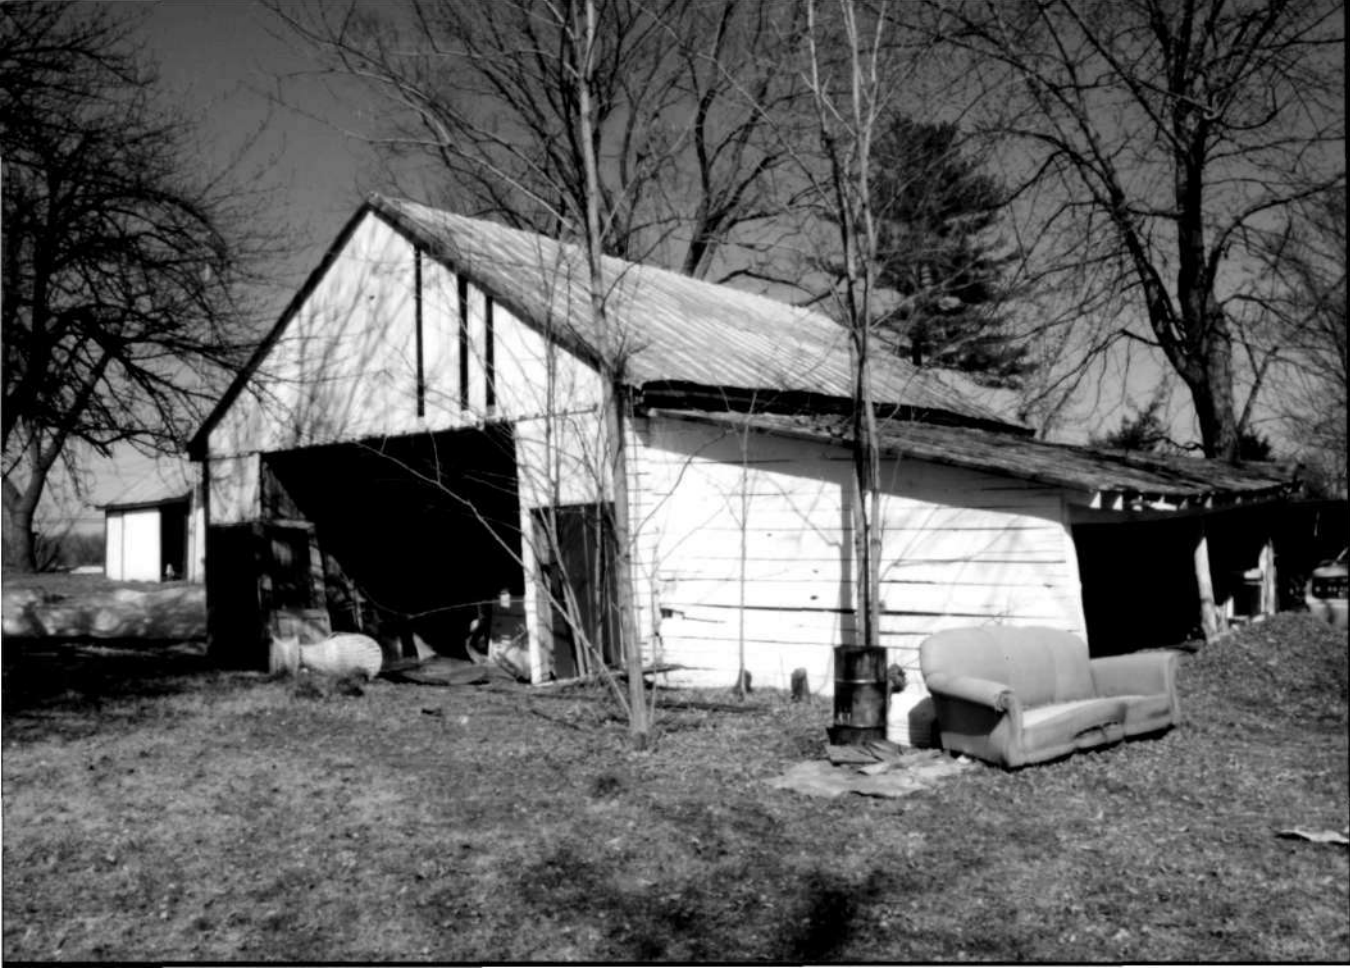
23 OF 26

The wood-frame wagon shed/corn crib was constructed ca. 1895 southwest of the bank barn. The rectangular-shaped wagon shed was constructed with circular-sawn framing members and wire nails. The shed has large openings on the north and south elevations for drive-through wagon passage. Corn cribs flank the wagon area; each corn crib is accessed by a wood door on the south elevation. The gable roof is sheathed in V-groove metal. Exterior walls are clad with vertical wood siding on the gable ends and with horizontal wood siding on the east and west elevations. A shed-roof addition constructed by 1945 is attached to the east elevation (Pahlow 1945). The addition is clad with vertical and horizontal wood siding; the roof is sheathed in metal. The east elevation of the addition is open and is supported by a central telephone pole.

CORNER / WAGON SHED - SOUTHEAST CORNER

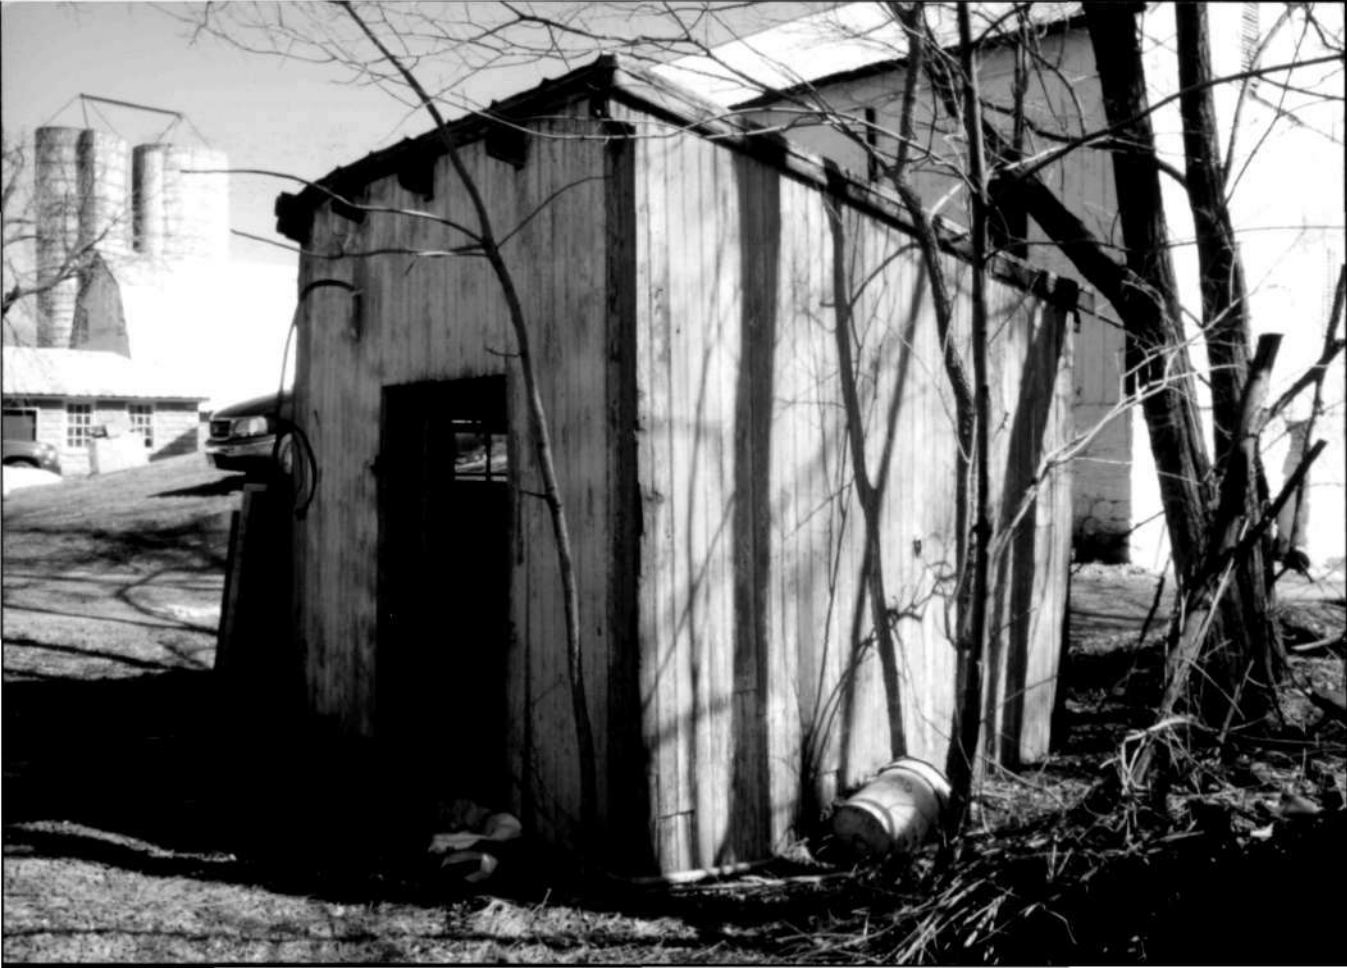
The small, square, wood-frame shed was constructed ca. 1950 east of the wagon shed/corn crib (Pahlow 1945). The shed faces west. Exterior walls are clad with tongue-and-groove, vertical wood siding. The structure has a shed roof sheathed in V-groove metal. The front (west) elevation contains a tongue-and-groove wood door. A six-light, fixed, wood-frame window pierces the north elevation.

MARCH 2010  
SMALL SHED - SOUTHWEST CORNER  
24 OF 26
